Evaluation of Groundwater Level Data from Estancia Basin Monitoring Wells

May 2017

HydroResolutions, LLC

East Torrance Soil and Water Conservation District

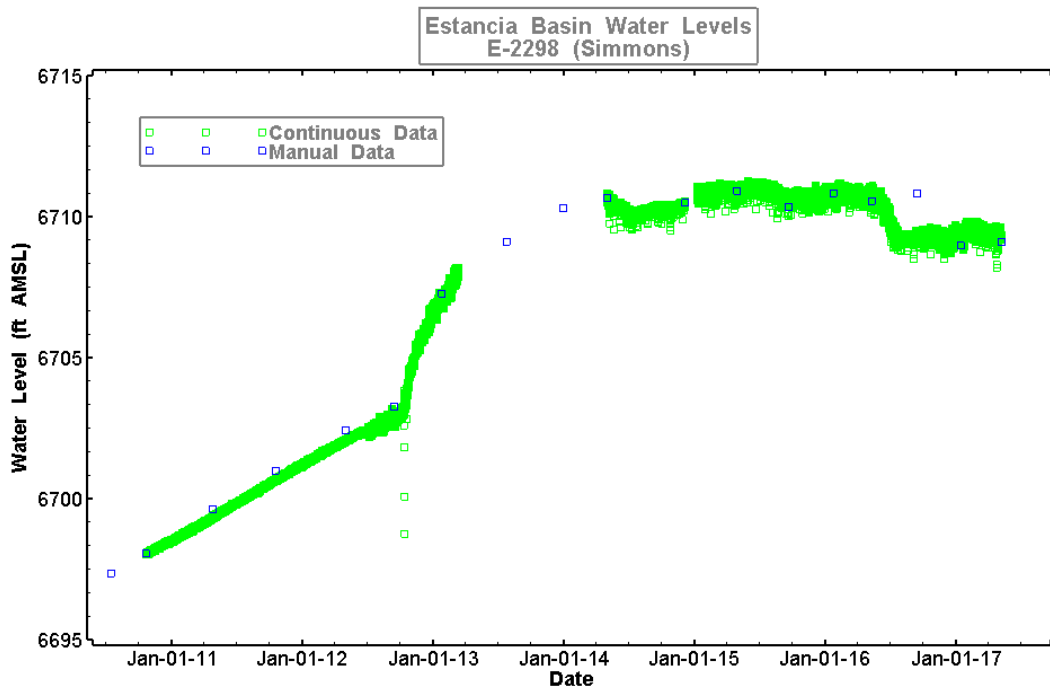
Figure 3. Water levels measured in well E-2298.

Near the northwest boundary of the basin, water levels in E-2298 (Figure 3) do not show any response related to irrigation pumping and were previously seen to be linearly increasing. Following the drilling of a replacement well in close proximity to E-2298 during the second half of 2012, the rate of the water level rise increased for about 6 months. The water level has been relatively constant since the beginning of 2014.

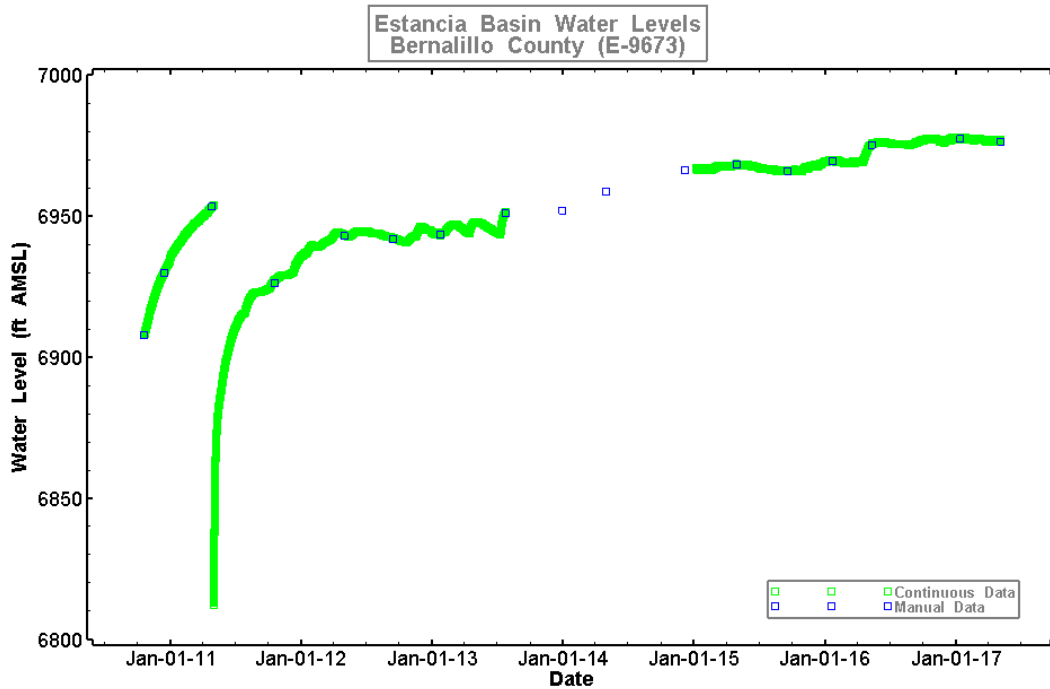
Figure 6. Water levels measured in well E-9673.

South of E-2298 along the western edge of the basin, E-9673 (Figure 6) does not display seasonal water-level changes that would indicate it is affected by irrigation pumping. In May 2011, water was pumped from E-9673 for water-quality analysis. At the end of the water-quality sampling, the water level in E-9673 had decreased from about 6954 ft AMSL to 6812 ft AMSL and subsequently started to recover. The water level was relatively constant through 2012 at a level approximately 10 ft lower than it was prior to water-quality pumping. Since January 2013, however, the water level at this location has increased approximately 35 ft and is now at 6976 ft AMSL.

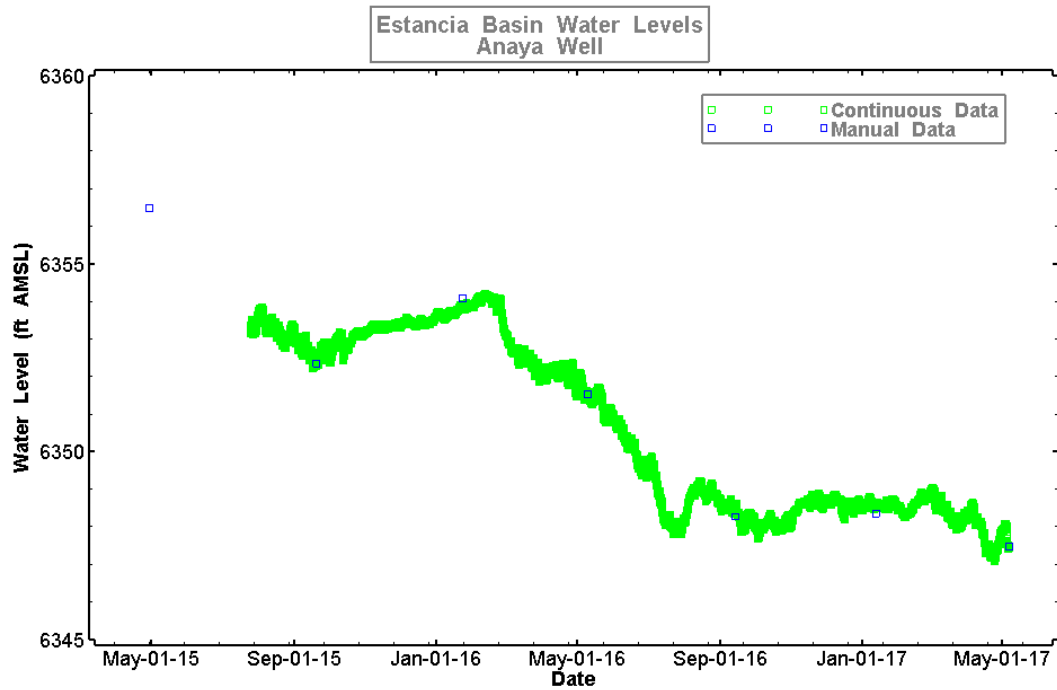
Figure 7. Water levels measured in the Anaya well.

The Anaya well, located approximately 2 miles east of Edgewood (Figure 2), was added to the monitoring network in April 2015. An initial manual water-level reading was taken in this well on April 29, 2015, and an INW transducer was subsequently installed on July 25, 2015, to begin continuous monitoring (Figure 7). The data to date suggest that water-level seasonal variations due to irrigation pumping in the basin are evident in this well.

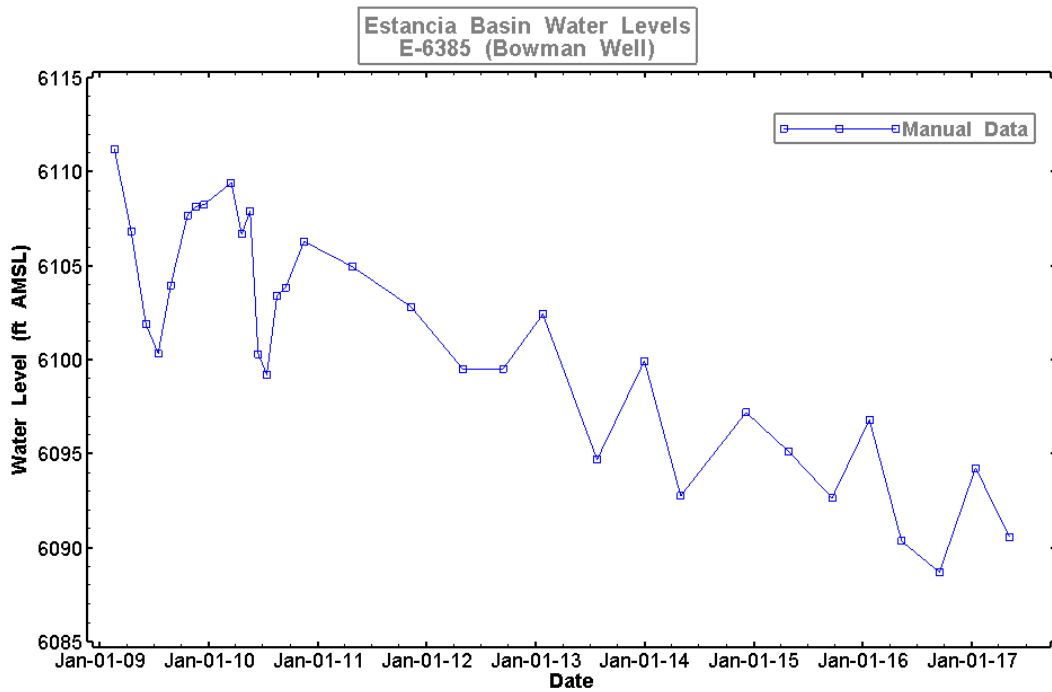
Figure 9. Water levels measured in well E-6385.

Magnum Steel (Figure 8) and E-6385 (Bowman) (Figure 9) in the north central part of the basin clearly show the seasonal variations associated with irrigation pumping and both exhibit an overall long-term decline. Note that the Magnum Steel well was not accessible during this most recent monitoring run.

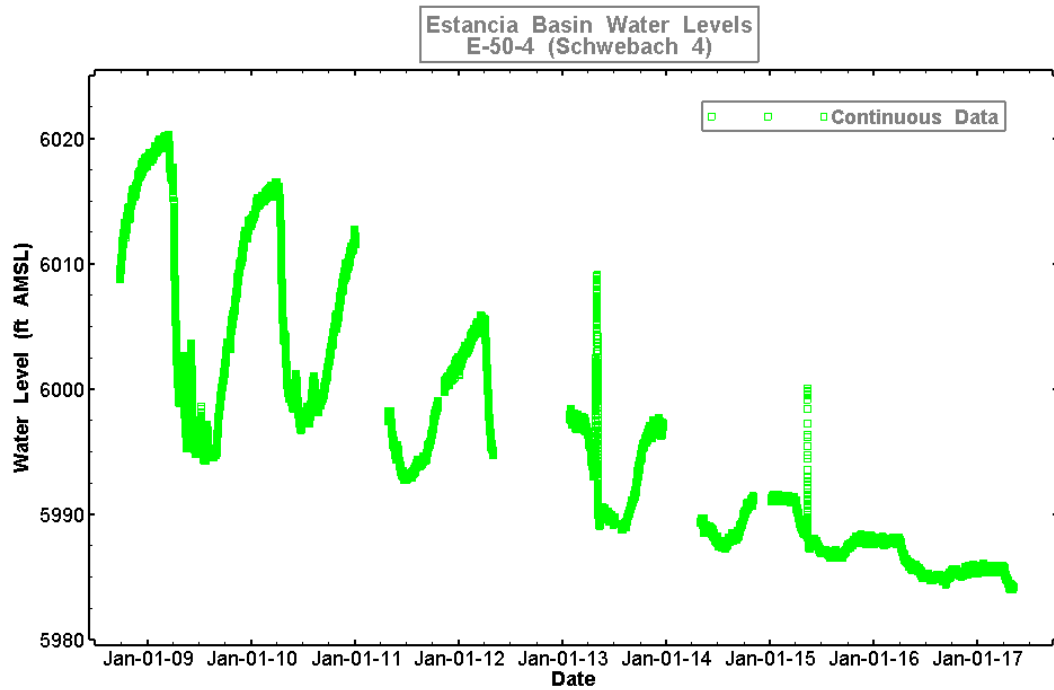
Figure 11. Water levels measured in well E-50-4.

Wells E-50-1 (Schwebach 1) (Figure 10) and E-50-4 (Schwebach 4) (Figure 11) near the center of the basin (Figure 2) show the effect of seasonal irrigation pumping. Water-level changes often exceeded 20 ft between the start and end of the irrigation season when monitoring began in 2009. Long-term water levels in the vicinity of wells E-50-1 and E-50-4 are clearly declining, but the magnitude of the seasonal fluctuations has decreased in E-50-4 over the past two and a half years. The apparent static water levels at about 6417 ft AMSL in well E-50-1 resulted when the water level dropped below the level of the transducer in the well. The length of time that the water level was below the transducer steadily increased each year. The peak (maximum recovery) seasonal water levels in E-50-1 decreased to the point where the transducer was barely submerged during the non-irrigation season. A previous collapse in E-50-1 prevented the transducer from being installed at a greater depth, so the transducer was removed from this well on May 1, 2014, after the final data download.

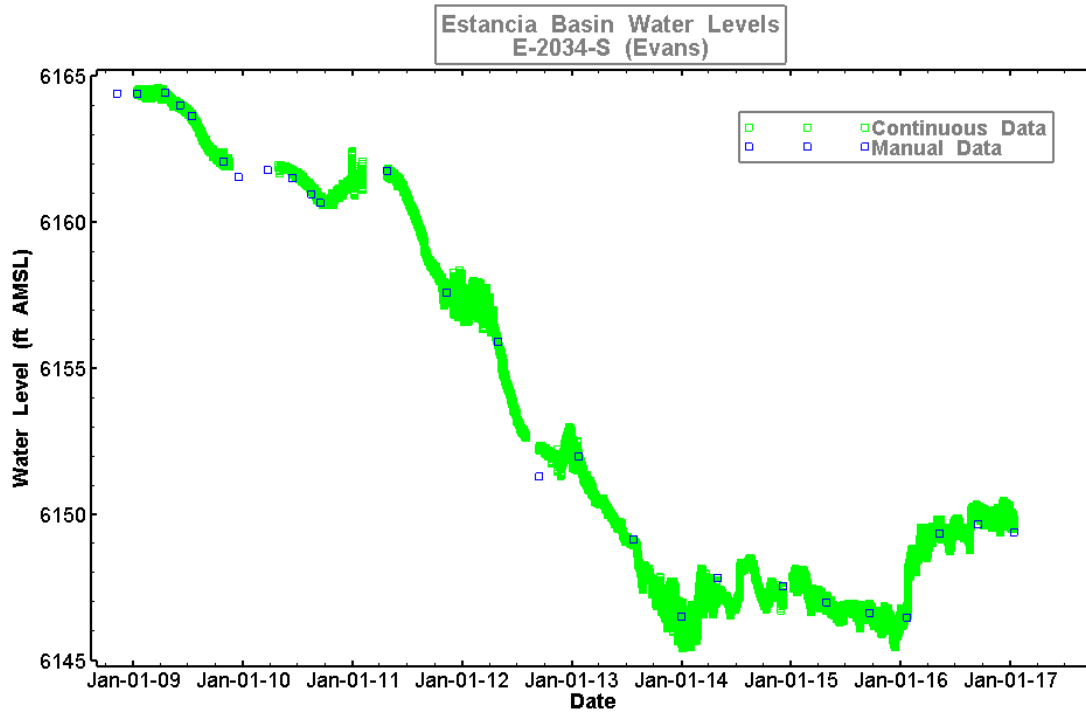
Figure 12. Water levels measured in well E-2034-S.

Well E-2034-S displays an attenuated irrigation pumping signal (Figure 12) relative to E-50-4, located about six miles to the northeast. The water level at E-2034-S has decreased approximately 20 ft since the start of monitoring in late 2008, but the water level has been relatively constant since January, 2014, and has even increased approximately 3 ft since January, 2016. Recently installed fencing prevented access to E-2034-S during the most recent monitoring run.

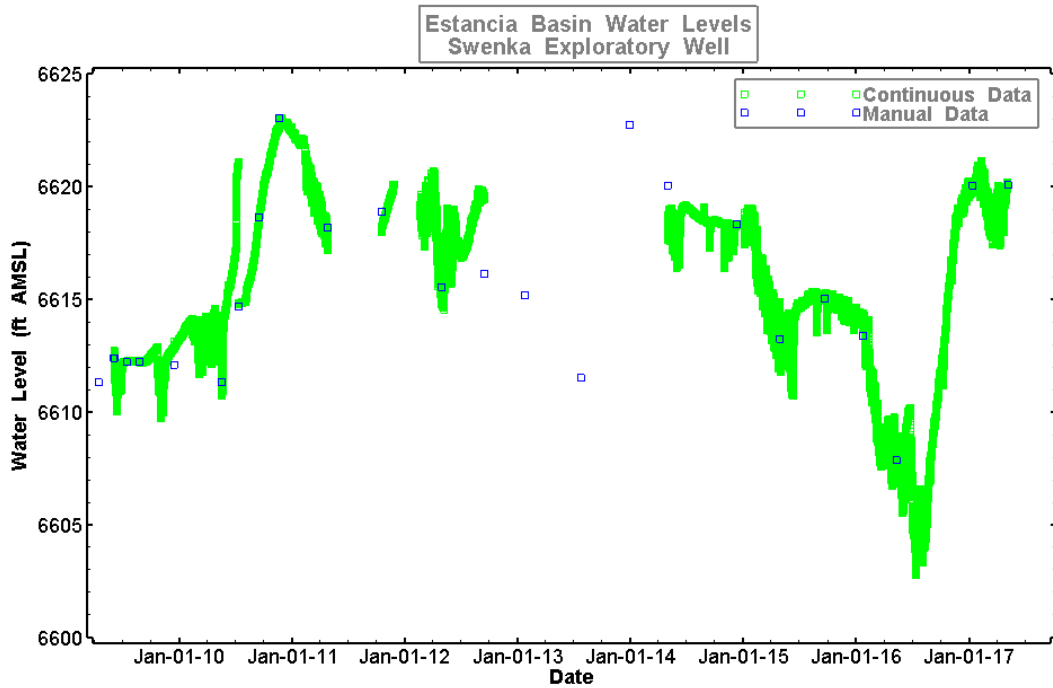
Figure 13. Water levels measured in the Swenka Exploratory well.

The Swenka Exploratory well (Figure 13) water levels have been highly variable since the start of monitoring in 2009, but there is no clear indication that they are being affected by irrigation pumping in the basin. The difference between the maximum and minimum water levels observed in this well has been approximately 20 ft.

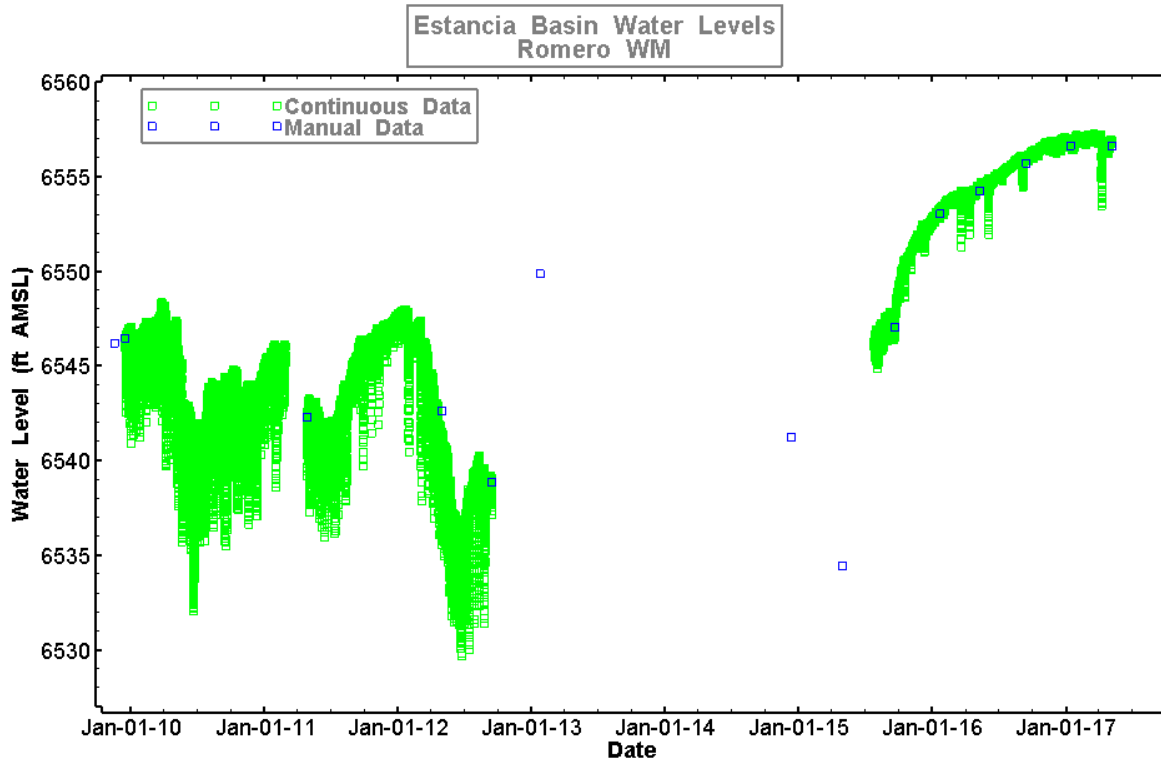
Figure 14. Water levels measured in the E.B. Romero WM well.

Further south, but still on the west side of the basin, E.B. Romero windmill (Figure 14) shows both short-term windmill pumping cycles as well as the seasonal irrigation pumping cycles. The current water level at the E.B. Romero windmill is at its highest level since the start of monitoring at this location in 2009.

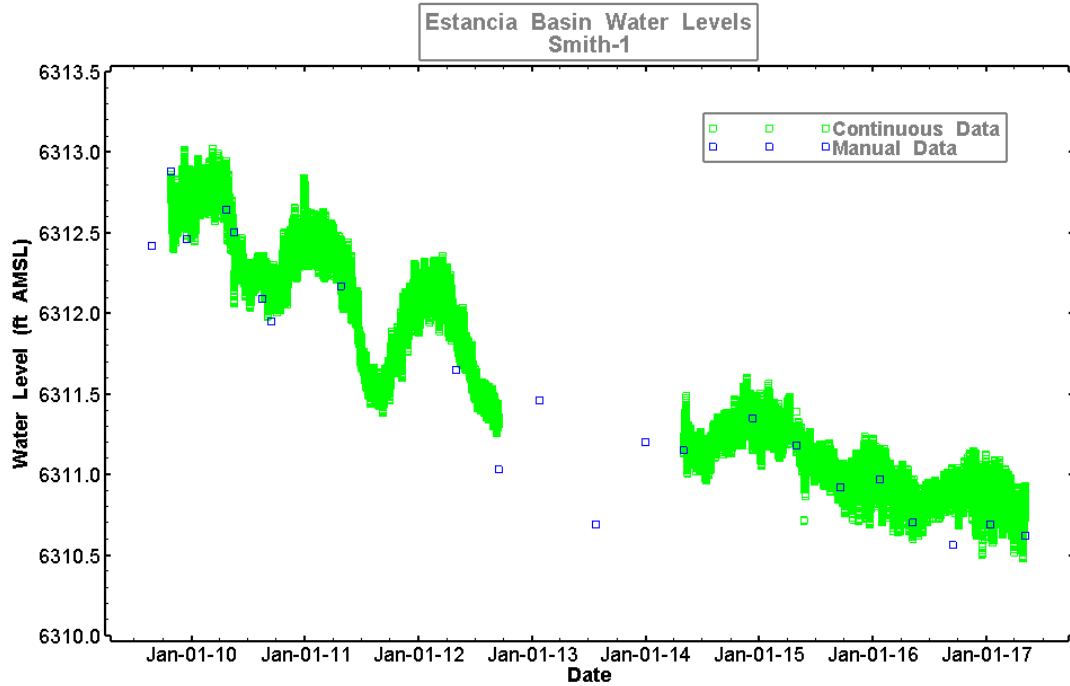
Figure 15. Water levels measured in the Smith-1 well.

Continuing south along the west side of the basin, Smith-1 (Figure 15) shows the seasonal irrigation pumping cycles and displays a long-term water-level decline. Similar to the water levels in E-50-4, the magnitude of the seasonal fluctuations in Smith-1 has decreased since the start of 2014.

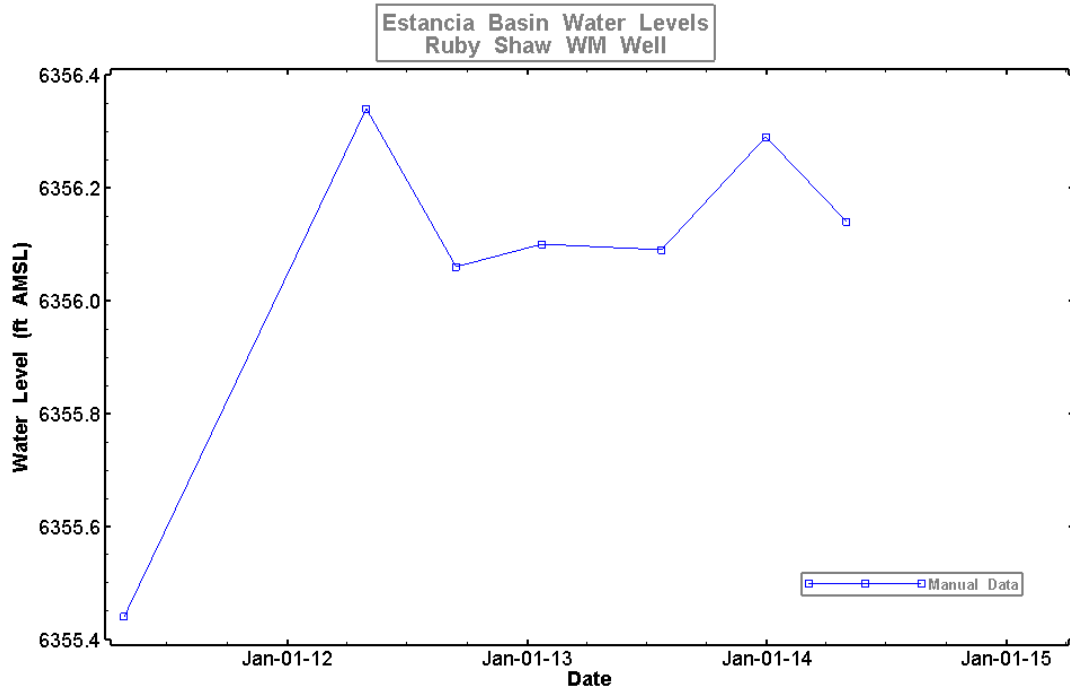
Figure 16. Water levels measured in the Ruby Shaw windmill well.

Manual water level readings from the Ruby Shaw Windmill well are shown in Figure 16. Manual measurements since mid-2011 indicate that water-level variations at this location are minimal and exhibit no clear trend. As of December, 2014, this windmill was back in service, so monitoring has been discontinued.

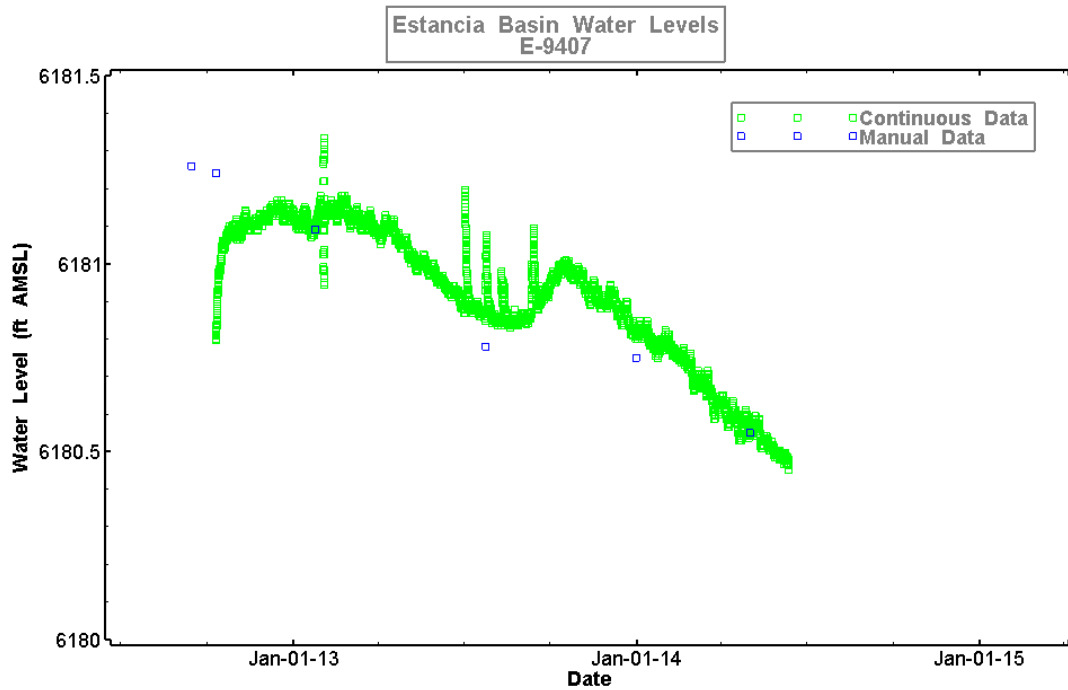
Figure 17. Water levels measured in well E-9407.

Manual water-level measurements in well E-9407 (Figure 17) started in September 2012 and a pressure transducer for continuous monitoring was installed in October 2012. There appeared to be a slight downward trend in water levels at this location, with the water level decreasing about 0.6 ft since the start of monitoring. When the transducer at this well was checked on December 15, 2014, it was determined that some portion of the well had collapsed and the transducer was retrieved from under about 55 ft of mud. Monitoring of this well has been discontinued.

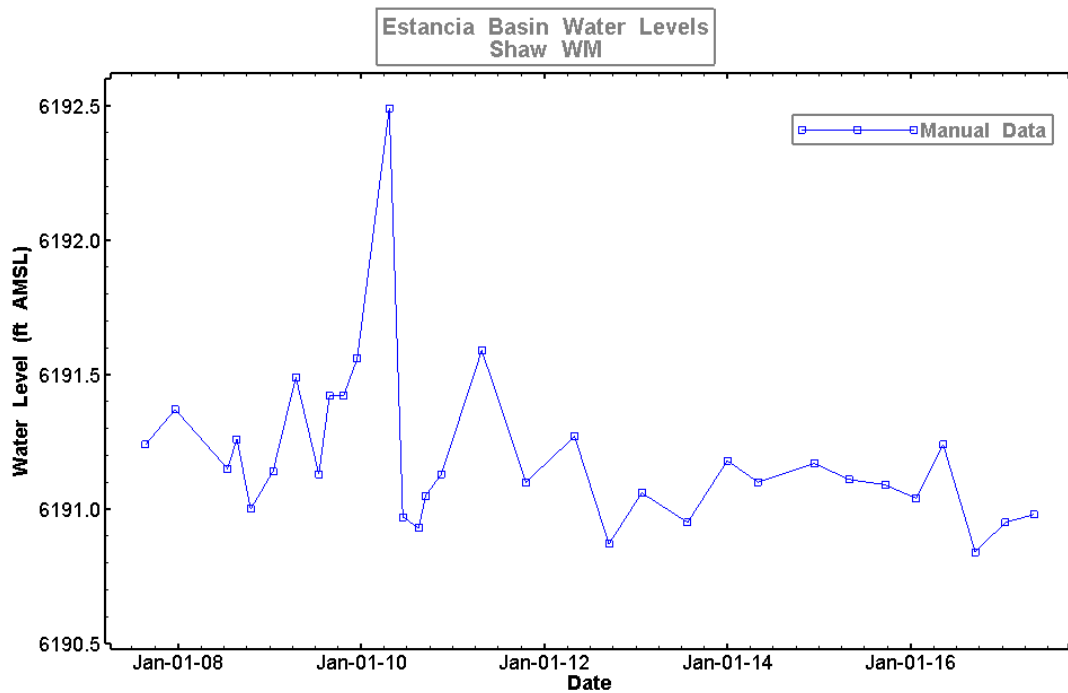
Figure 18. Water levels measured in the Shaw WM well.

The Shaw WM (Figure 18) water levels show the irrigation pumping signal, but the average water level at this location appears to be relatively constant, with no net change over the past 8 years. The magnitude of the seasonal fluctuations decreased at this location between January 2014 and January 2016, similar to the responses in E-50-4, E-2034-S, and Smith-1. The most recent readings, however, suggest a return to the previous response magnitudes.

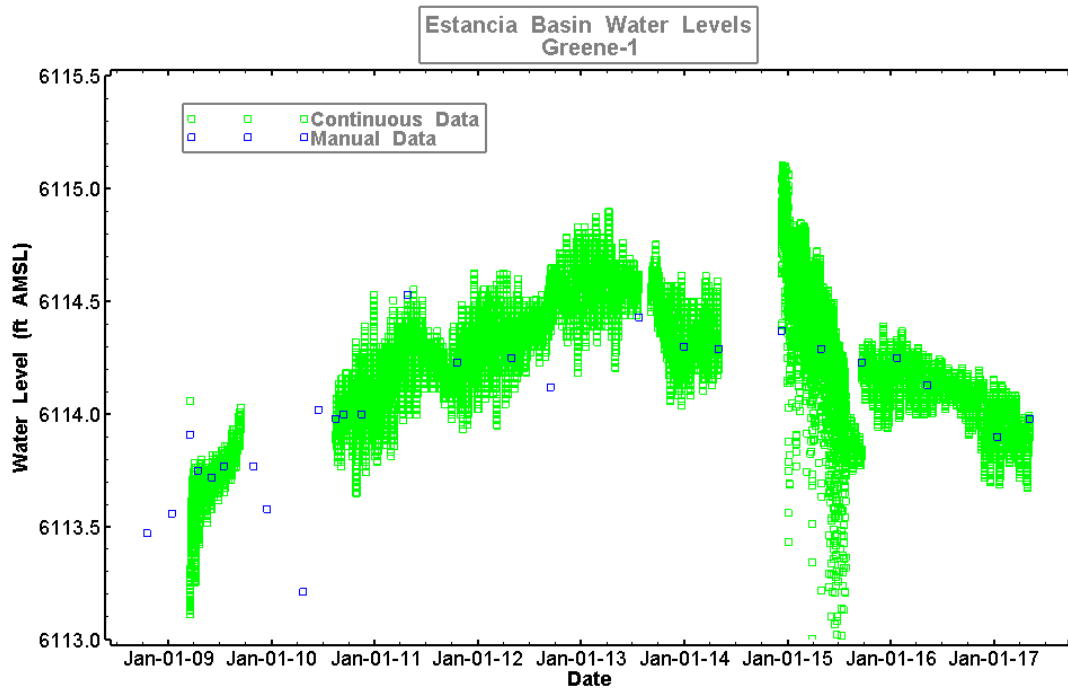
Figure 19. Water levels measured in the Greene-1 well.

Neither Greene-1 (Figure 19) nor Greene-4 (Figure 20) in the southern part of the basin (Figure 2) shows the effects of irrigation pumping. The water levels at Greene-1 displayed a slight upward trend from 2009 through 2013, but they appear to have been relatively constant since the start of 2014. As noted previously, monitoring was discontinued in Greene-4 due to its remote location. During the 3 years that Greene-4 was monitored, the total variation in the water level was about 11 ft, but the net change between the first and last data points was effectively zero.

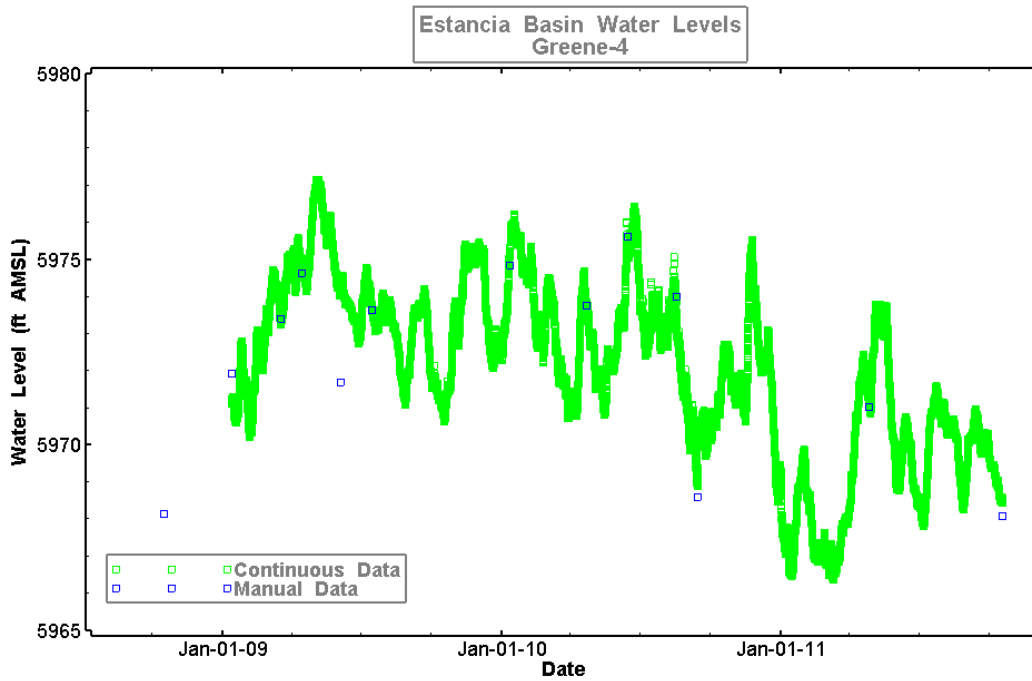
Figure 20. Water levels measured in the Greene-4 well.
